# Hampshire Antique Restoration

**OBJECT:** 18<sup>th</sup> century Boulle marquetry clock case

**OBJECT NUMBER:** 6743 - 07 - F

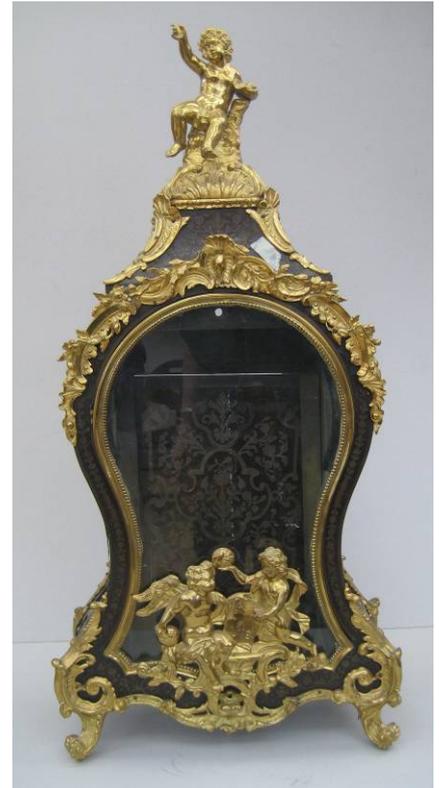
An 18<sup>th</sup> century Boulle style marquetry bracket clock case, veneered in tortoiseshell and engraved brass on a stained oak substrate, heavily mounted with ormolu bearing a duty stamp for 1740<sup>(supplementary pic 1)</sup>.

Evidence of previous restorations to both brass and tortoiseshell areas. Heavily accreted (tortoiseshell) with significant corrosion products on brass areas<sup>1</sup>. Around 25% loss of brass marquetry,<sup>2</sup> around 10% loss of tortoiseshell<sup>3</sup> with significant cleavage of brass from substrate<sup>4</sup> (approximately 75%).<sup>5</sup>

Extensive oil staining to the baseboard<sup>6</sup> causing significant cleavage, shrinkage to oak substrate on rear door. Extensive cleavage and losses to brass edge strips.<sup>7</sup>

Lock missing from PLHS frame and damage to brass keep on ormolu door.

- Loose areas of oak substrate will be re-glued using hot hide glue
- Surface accretions will be removed from tortoiseshell.
- All remaining brass will be lifted, corrosion products removed re-attached with fish glue.
- Missing sections of brass will be cut from brass sheet, engraved and fitted where necessary
- Missing sections of tortoiseshell will be replaced using epoxy resin pigmented with earth pigment and laid over a barrier coat of fish glue
