CONDITION REPORT AND TREATMENT PROPOSAL

OBJECT: A mid 18th Century South German Fauteuil

OWNER: Edward James Foundation

TREATMENT REPORT

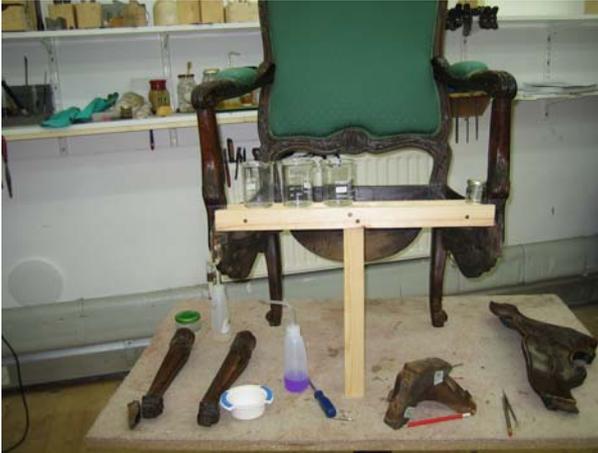
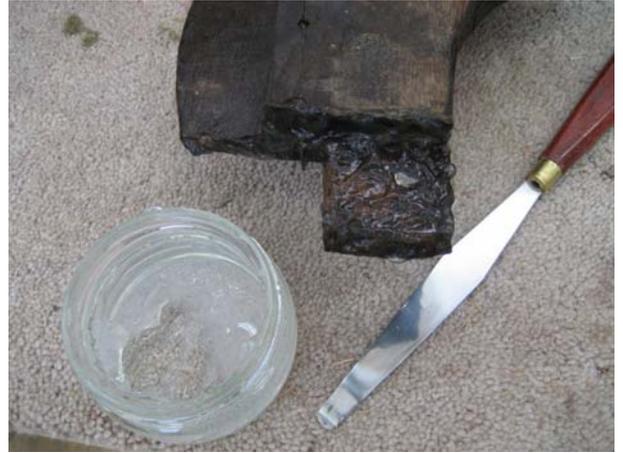
1. Disassemble and remove old glue residue

FTIR spectroscopy was carried out using fragments of glue from the previous repairs and this was shown to be a mixture of casein and PVA adhesives.

The loose and damaged parts were carefully removed and all screws and shards of timber were set aside and labelled. A jig was made to support the remaining frame whilst restoration was in progress.

De-ionised water suspended in Laponite was used to remove the old hide glue and the casein and PVA as it was applied over the existing hide glue.

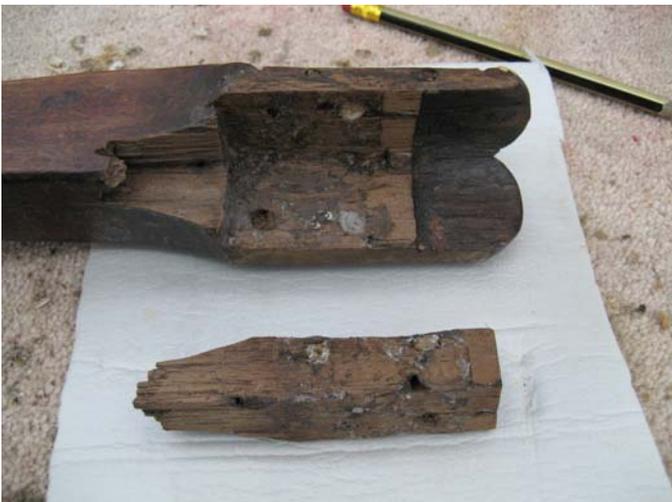
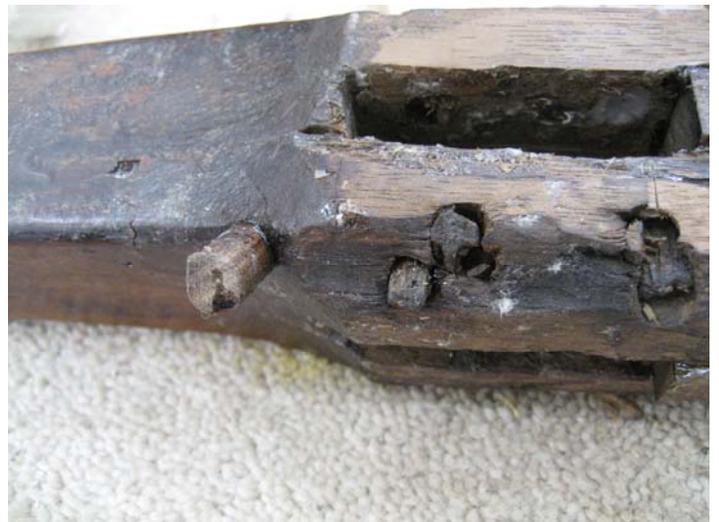
2. Repairs to PR front leg

The fracture visible where the PR leg is detached shows several previous repairs. Dowels have been inserted to strengthen the non original loose tenon on the PR seat rail. The tenon that was present on the PR of the front rail has been removed and replaced by a loose tenon at some stage. This joint has been glued together with modern adhesives. An IR spectroscopy examination of some fragments of this adhesive suggest a combination of Casein and PVA type adhesives has been used.

The broken away inside section was found to register well in its original position and glued back into place using hide glue. The hole present after the removal of a previously inserted nail was enlarged to accommodate a riven walnut peg.

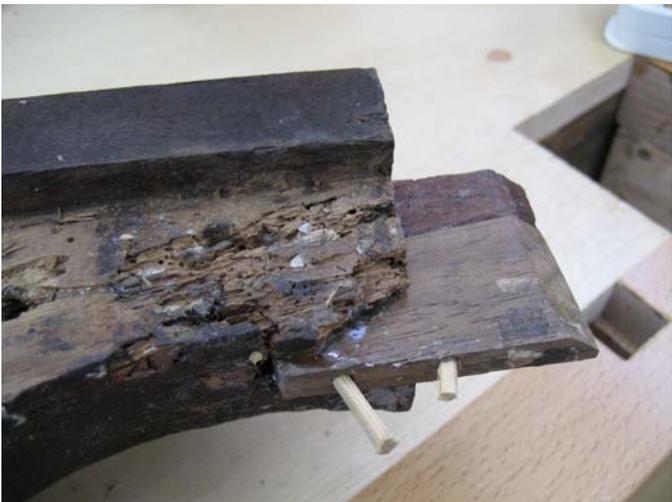
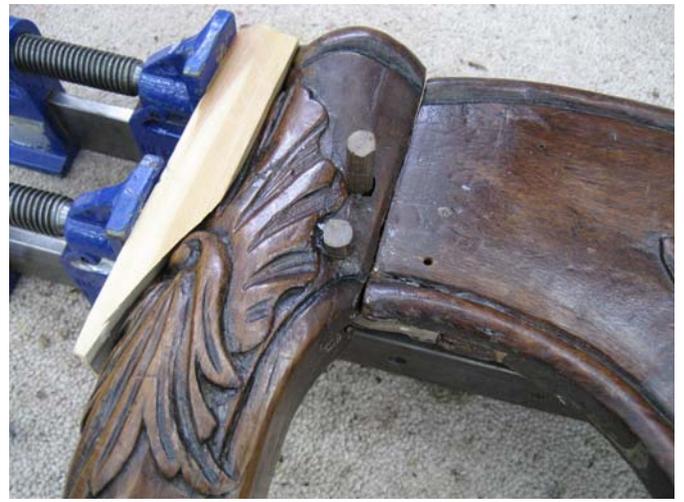
4. Splices to PR front apron tenon

The PL apron tenon has been lost to common furniture beetle damage and has been replaced by a loose tenon which is now shattered, also glued in with the adhesive mixture previously mentioned.

A large part of the PR apron tenon was lost due to common furniture beetle damage; a new section was carved from walnut and glued into place with hide glue. Bamboo was used as a cross grain dowel to strengthen the glue line.

The front gate was then reassembled using replacement cleaved walnut draw-pegs wherever the original was damaged or lost.
