Hampshire Antique Restoration

OBJECT: late 18th century carved and gilded looking glass frame

DESCRIPTION OF TREATMENT:

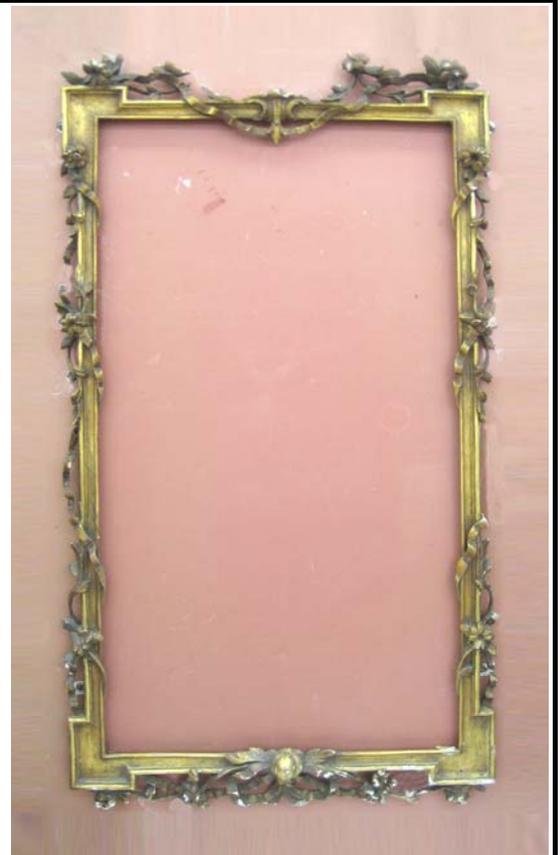
A late 18th century Gilded carved pine looking glass frame, the design a combination of flowers and classical ribbons, with a stylised squash at the centre of the lower member. These devices appear to entwine a concave and beaded rectangular frame with break corners, but each of the 4 sections is carved from the solid (consistent with European pine – by eye).

The main central carved motif is absent;¹ there are several small losses (flower petals and leaf tips) a large section of ribbon is missing from the PL side.² The mirror plate was removed prior to photography to allow clearer documentation and for safe stowage for the duration of the conservation treatment.

The numerous small fractures around the larger losses will need consolidation. Careful observation of the remaining areas of carving provides evidence suggesting a focal point for the garlands on either side of the central losses. This when combined with research undertaken on comparable looking glasses this suggests the missing area was a classical urn. Once a design has been fully developed new timber will form the basis of the restoration, after carving it will be water gilded in the traditional manner.
