Hampshire Antique Restoration

CONDITION REPORT AND TREATMENT PROPOSAL

OBJECT: Mid 17th Century Italian Walnut Armchair

TREATMENT REPORT

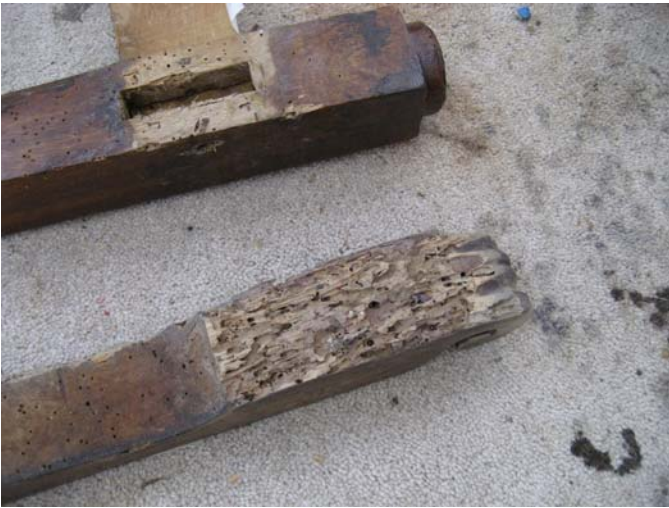
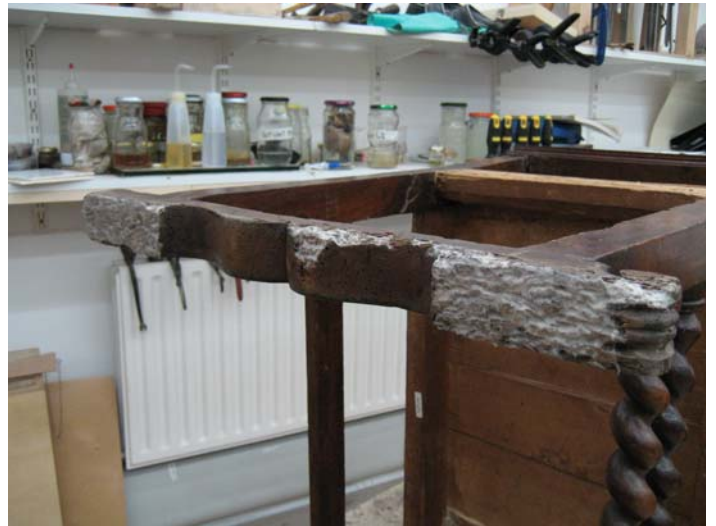
3. Consolidation

There is evidence of extensive common furniture beetle damage to the item, especially the front legs and both feet rails, which are extensively weakened eroded and pitted with flight holes. All of this previous infestation appears to be dormant. Stopping wax has been used to previously fill the flight holes – a large amount of which is now missing.

After research it was decided to use Butvar 98 as a consolidant (see report). Damaged areas were treated with a 5% W/V solution (dissolved in IMS) at first then increasing to a 10% W/V solution. After drying Japanese tissue was glued into place with 10% Butvar 98 to act as physical barrier before casting in Bencon epoxy putty to replace existing losses.
