CONDITION REPORT AND TREATMENT PROPOSAL

OBJECT: Early 19th Century Pietre Dure Marble Specimen table

OBJECT NUMBER: 2345-08-F

OWNER: Edward James Foundation

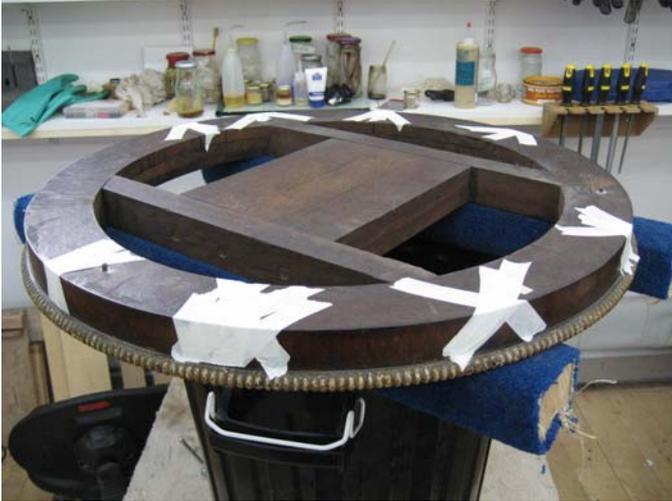
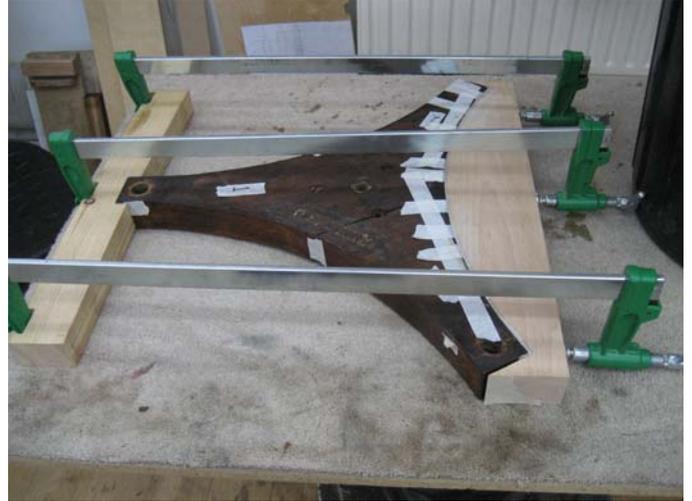
2. Veneer repairs to base

There is a witness mark underneath the base around the bolt that holds the base to the column providing evidence that a washer has been lost. This structurally essential retaining bolt currently bottoms out in the hole, and is not performing its intended function. Several areas of original veneer have cleaved away from the substrate.

The base has been previously restored and several replacement areas of rosewood veneer, some rather crudely fitted, and quite visible and therefore detracting from the original aesthetic quality of the piece (Picture 7). an old repair composed of iron straps let into the oak substrate to attempt to consolidate a failure

Cleaved veneer was found using the tapping method, and the sections marked before injecting hot hide glue underneath and cramping with masking tape. Missing veneer was replaced with sections of period rosewood veneer and a jig was made to allow for cramping on the curved surfaces of the trefoil base. Some minimal in-painting was done at this stage to harmonise the replacement sections using shellac and earth pigments.

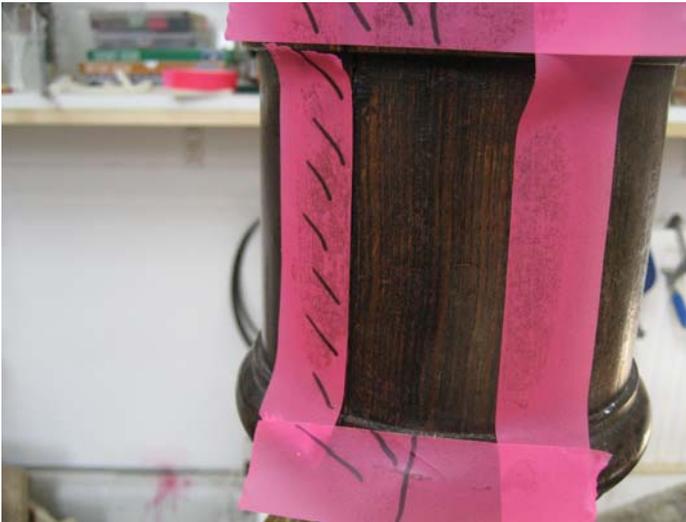
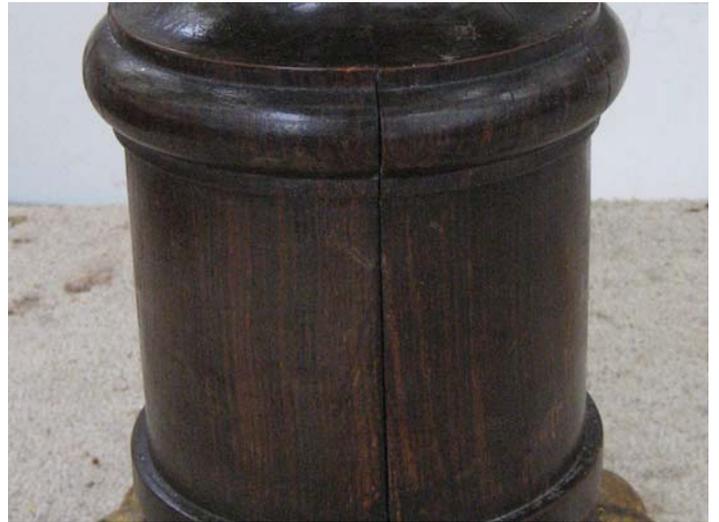
3. Consolidate faux rosewood finish

The joint between the column and the block appears sound with no discernable movement. Localised areas of the simulated rosewood finish on the column have degraded producing a cloudy and unsightly finish. There are also heavy losses to the gilded areas and degradation of the gilt surface lacquer (Picture 6).

The faux rosewood finish was tested and found to be a shellac based finish soluble in IMS. A test area was isolated and found to respond well to saturation with solvent, removing the cloudy appearance and consolidating the friable surface. The whole column was treated in this way using IMS applied with a pony hair brush and allowed to air dry uninterrupted.

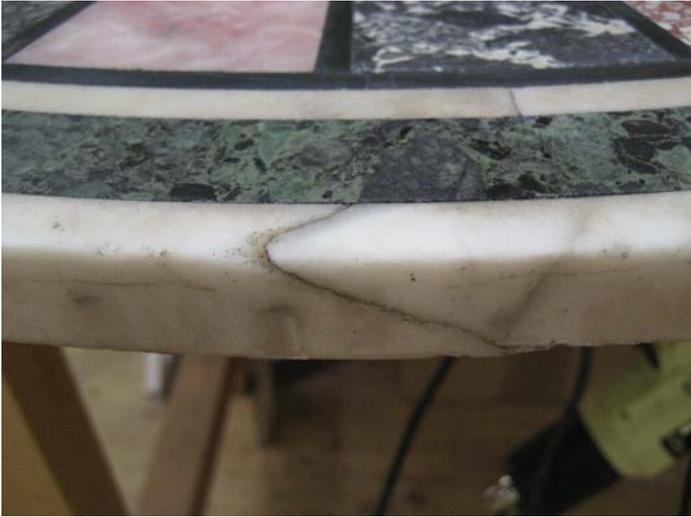
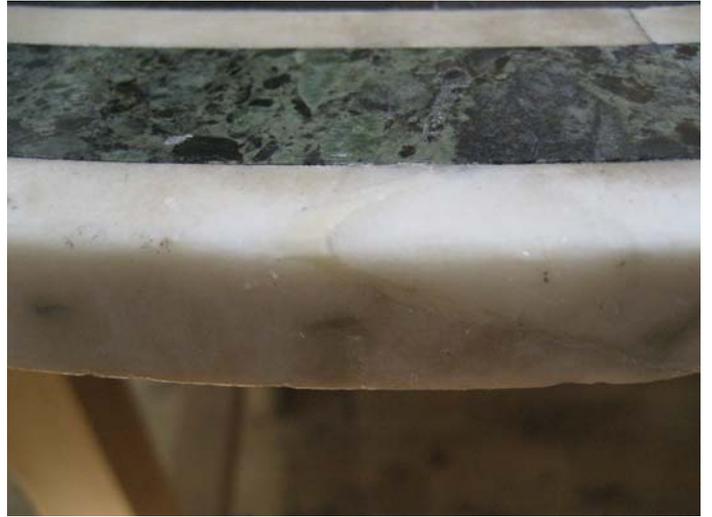
There is a crack in the marble substrate at the edge of the table top with obvious accretions, however this appears stable (Picture 2). The whole of the top of the piece is somewhat contaminated showing evidence of possible previous treatment with waxes or shellac. Some of the rosewood veneer on the apron under the top has become detached

The fissure in the marble substrate was steam cleaned before an amalgam of epoxy resin and marble powder was used as filler. The whole surface was then de-greased with acetone and white spirit before being rinsed with de-ionised water and allowed to thoroughly dry before having a protective coat of micro-crystalline paraffin wax applied and buffed to a lustrous finish.
