CONDITION REPORT AND TREATMENT PROPOSAL

OBJECT: Early 19th century Gilded Convex Mirror

OBJECT NUMBER: 2322 - 08 - F

TREATMENT REPORT

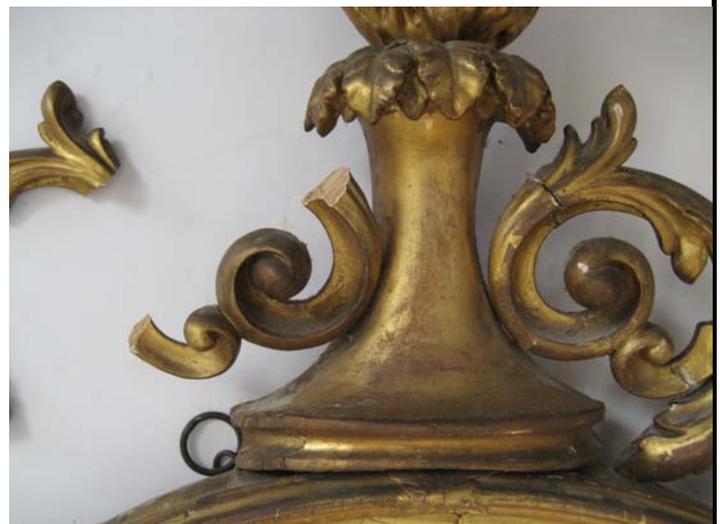
The upper carved decorative element is loose and has 2 breaks to the scrolled carvings that are nailed into place on either side of the central torch. One break has allowed a section to completely detach from the piece, the other is held in situ with an old adhesive repair. The top section carved to simulate the flames of the torch is also detached at the nailed join.

The mirror needs further disassembly to fully develop the treatment proposal, with the 20th century nails used to re-attach the carved elements replaced with bamboo dowels to reduce the damage caused to the wooden carcass by oxidation of the steel nails. The broken decorative elements will be glued back into place and the detached elements re-attached using bamboo dowels to replace the mild steel originals.

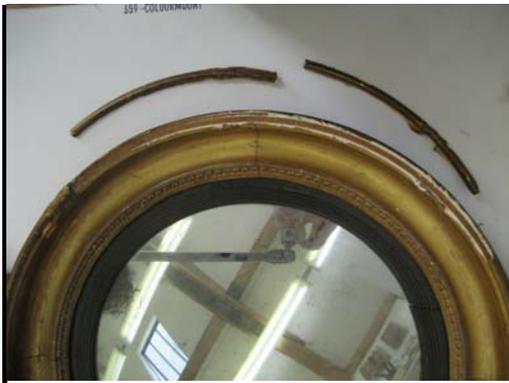
Two sections of the applied reed and ribbon carved feature that form the outer edge of the frame are detached and also have gesso and gilding losses. Additional areas of the applied feature are cleaved and have losses to the gesso ground.

After careful cleaning of the remaining gilding the loose and cleaved gesso will be consolidated using the injection technique and a suitable consolidant before building up the gesso in the lost areas using an acrylic gesso. New water gilding will then be applied in the lost areas in the traditional manner, and toned to match the existing gilding.

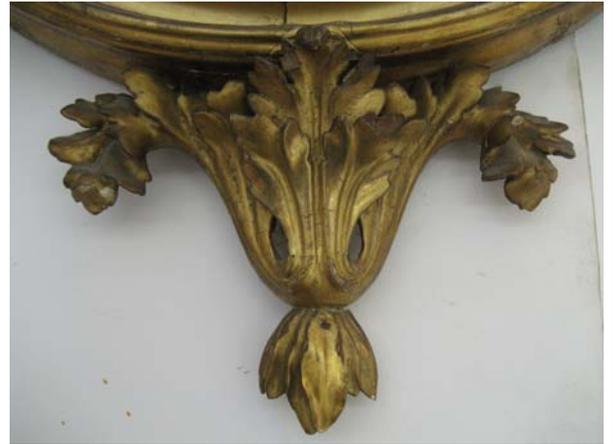
The lower applied section is loose and the husk detail at the very bottom is loose and

held into place by a badly nailed repair. There are various losses to the gilding particularly the leaf tips on this lower acanthus leaf carving. Bronze powders have been used to hide

previous gilding losses in the past; these have now discoloured leaving unsightly areas of finish on the gilding.

The discoloured bronze powders from previous restoration will be removed using a suitable solvent; this will reveal the full extent of the gilding losses.

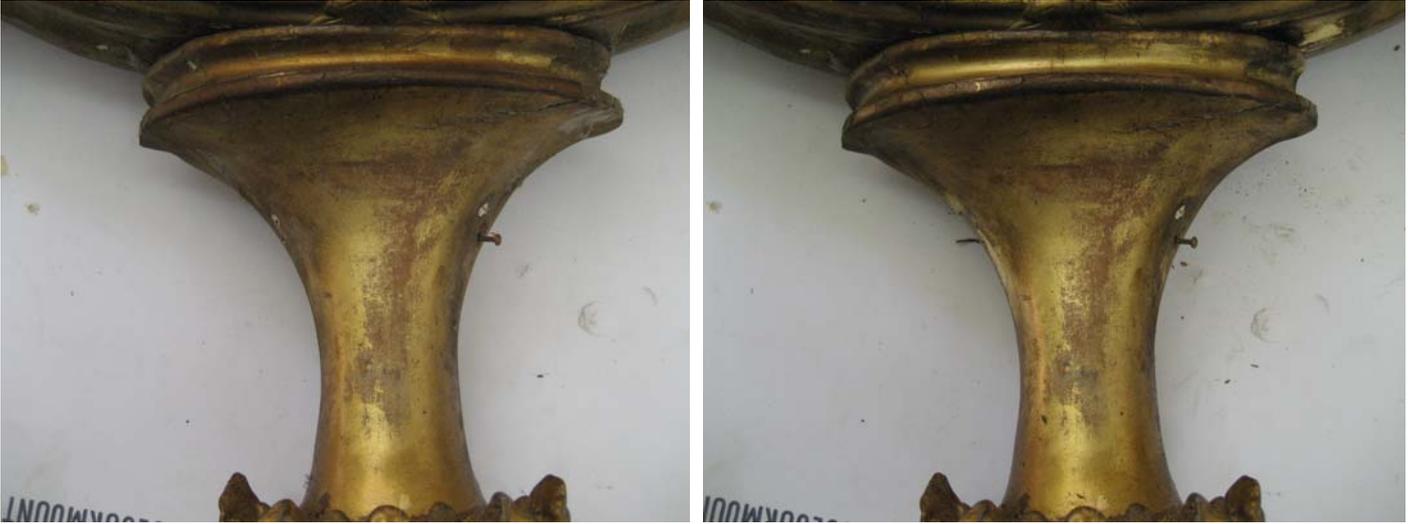
3. Removal of bronze powders

The top of these two pictures show the before and after of the removing the unsightly discoloured bronze powders from the surface using acetone on a swab. It was noticed the gilding was in fact in the best condition under these previously treated areas as the shellac polish used as a vehicle and adherent for the bronze powders seemed to have protected the surface.
