## CONDITION REPORT AND TREATMENT PROPOSAL

**OBJECT:** Early 19<sup>th</sup> century Mahogany work table

**OBJECT NUMBER:** 2278 - 06 - F

## TREATMENT REPORT

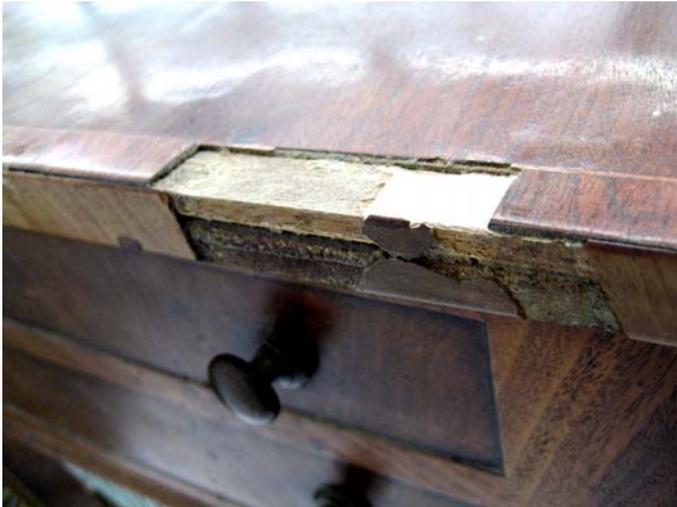
The table top is constructed from a 19<sup>th</sup> century solid mahogany, as are both leaves, but the cross banding used on both seems to have been glued to a piece of Oak fillet with the grain running at 90° to the carcass timber.

The stringing used between the main top veneer and the cross banding would traditionally have been repeated along the outside edge of the cross banding, this second string is not present. There is also evidence of a previous

moulding having been present underneath the Oak fillet.

The stringing and cross banding around the corners of the leaves are very awkwardly executed with poor choice of grain alignment and uneven radiuses.

There are new screws present holding the top onto the carcass, and clear evidence the top has been rotated through 180° at some time from mis-aligned screw holes in the substrate.

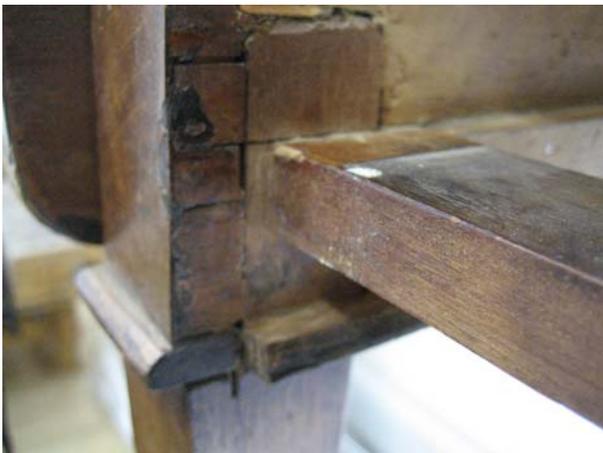
The open tenons securing the legs to the carcass are not only an incorrect technique for a piece of this date and quality, but are very poorly worked as can be seen here.

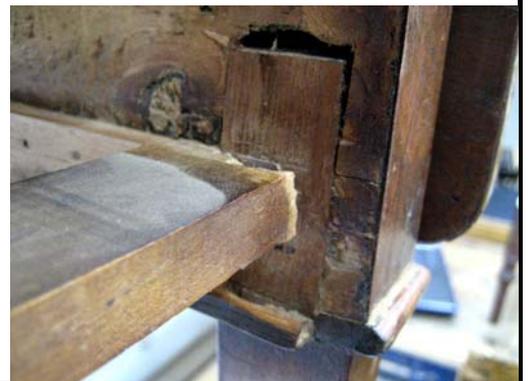
Evidence of a spoon

bit Auger (drill) having been used to rough out these joints in the carcass can be clearly seen here;

The timber used for the legs is a much later material more commonly found in late Victorian/Edwardian pieces.

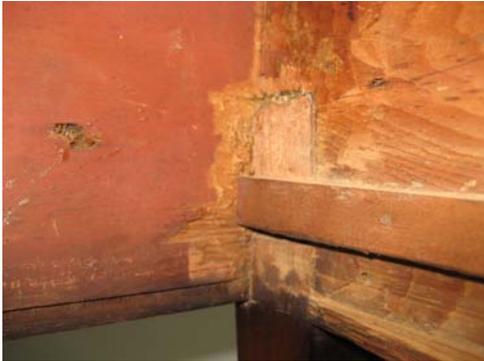
Further evidence of alteration can be seen here where the rear PLHS leg has been tenoned in ripping out timber from the rear cross member, providing unequivocal proof of this work having been done at a later date than the carcass was assembled.

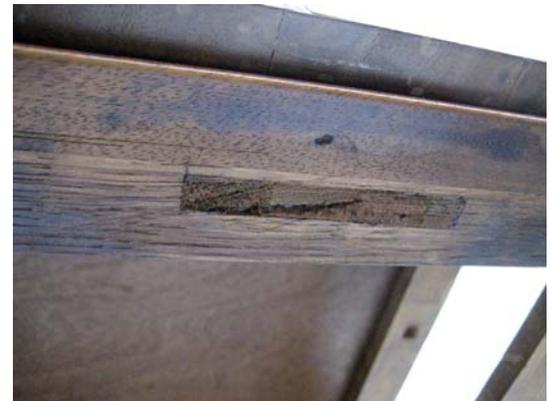
This view (looking up into PRHS of the carcass from below) shows a sawn off tenon (there is one present on the PRHS also. Saw marks visible here also suggest that an original part has been removed at a later date in a crude fashion.

The relative size of the remaining tenon suggests that the removed piece was substantial and most likely structural in application.
