Restoration of an English Eight-day longcase clock by Charles Robotham, Leicester

Circa 1790

This Report has been produced in order to summarise the work undertaken on the restoration of an English longcase clock.

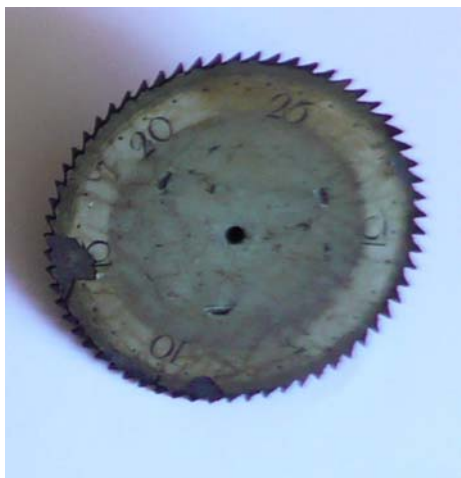
The dial did not appear to have had any previous restoration work and whilst most of the dial was in reasonable condition for its age, some of the numerals and the maker's name required reinstating. There was considerable damage to the day of the month ring (left).

Date ring: clean, remove loose and unsafe paint and repair damage; repaint and restore numerals and markings (see also picture on page 3).

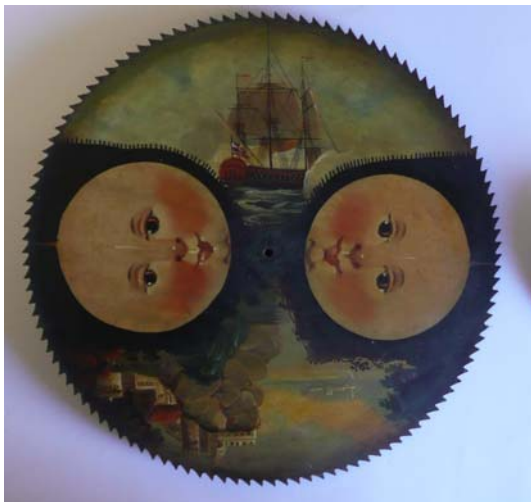
Research showed that the moon-phase dial was very similar in painted design as one found on a clock by John Hunter of Bridlington, North Yorkshire of the same period (1790), as shown below.

A number of clock dials around this period appeared to use the scene of a ship at sea in one half of the painting and a landscape scene in the other half. This was of course a time when the British Navy ruled supreme.

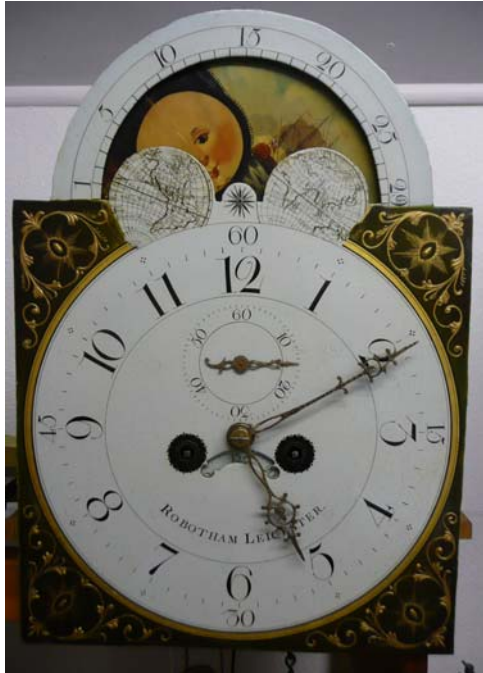
The dial is unusual in that both the minutes and hours are shown in Arabic, whereas the usual way was to show the hours in Roman numerals and the minutes in Arabic.

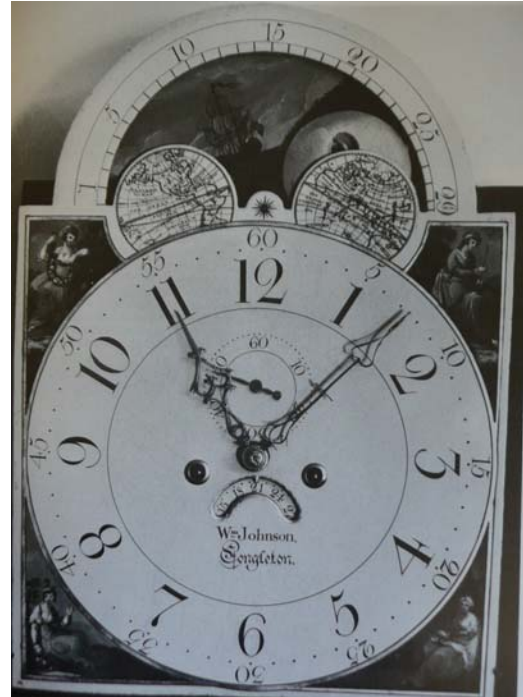
The picture on the right is of a dial by F. Byrne (Birmingham) of the same period. Note the unusual use of Arabic numerals on both hours and minutes. It was common for clockmaker's to purchase dials from specialist makers, and given that Leicester is not that far from Birmingham, it is quite possible that the dial on the Robotham clock is by Byrne. Note also the painting in the moon-phase.

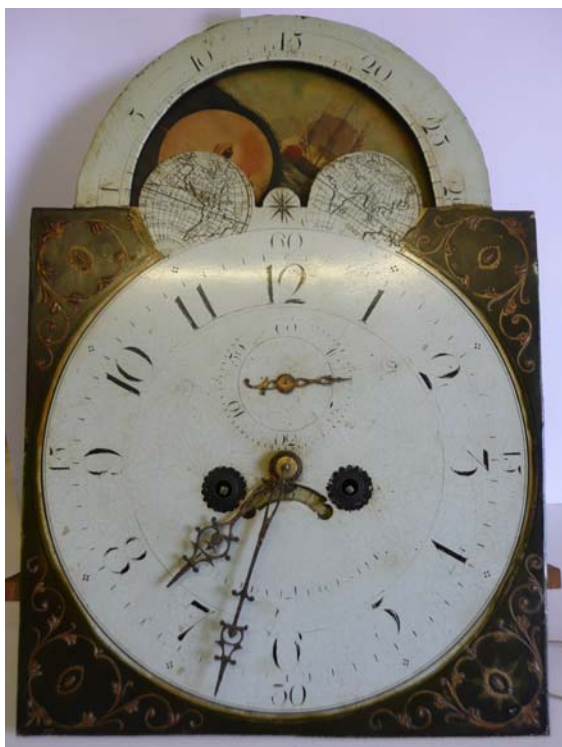
The dial, shown below in the condition received, was repaired by a professional dial restorer, the following work being undertaken:

Main dial: clean and repair chipped and scratched paint; restore all rings, Arabic numerals, names and ornamental details using fine quality Indian ink; accentuate gilding on raised gesso patterns and re-apply gold leaf to the hour ring.

Moon-phase dial: clean and repair chipped paint around mounting hole and polish.

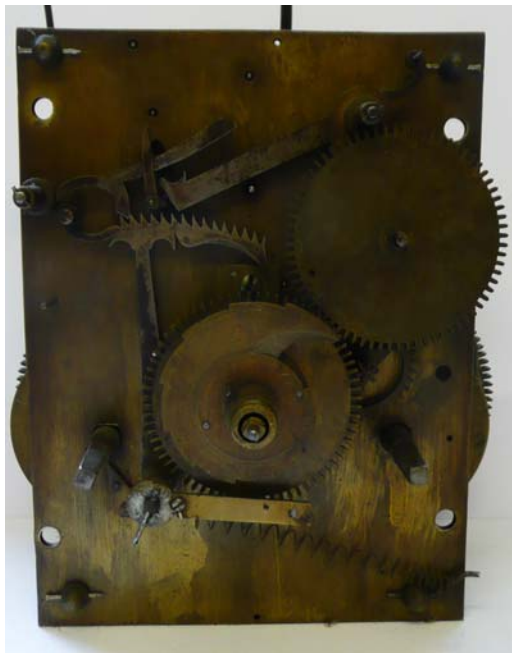
Under-dial work before.....

The picture on the left above shows the state of repair when received. Please note the Biro spring doing the job of the missing rack tail spring at the bottom of the picture. A new spring therefore needed to be made.

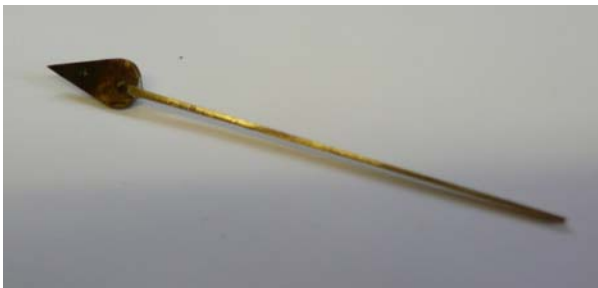
New spring being made and fitted to original 'tail'

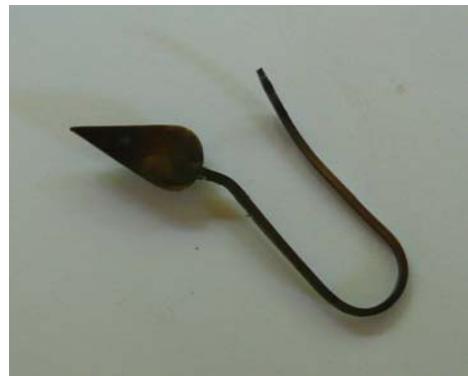
New spring bent to shape and 'aged'

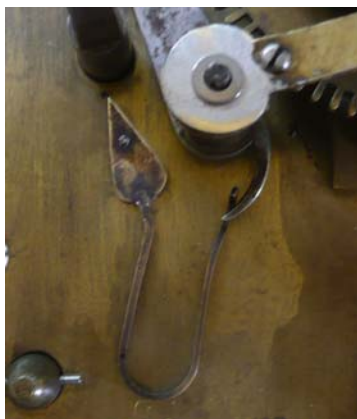
New spring fitted in place

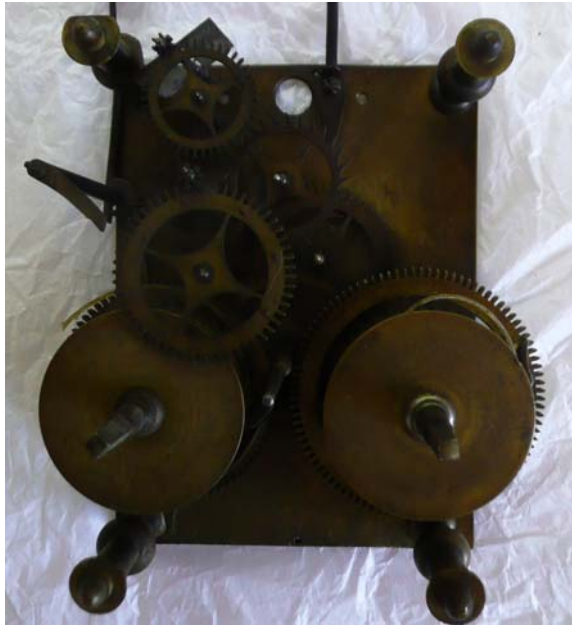
Detail of the movement before

The movement was in a satisfactory state of repair for its age. Pivots were polished and all pivot holes thoroughly cleaned of deposits. New natural gut line was fitted for the driving weights.

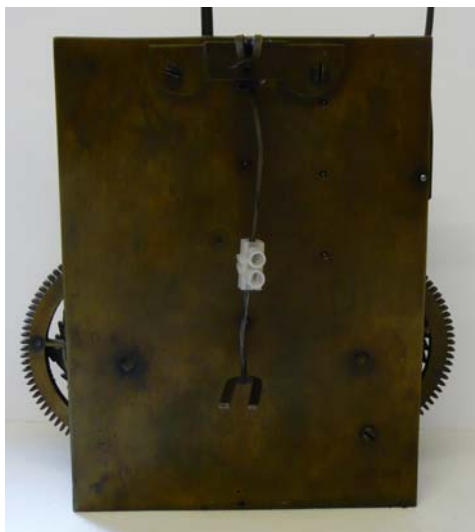
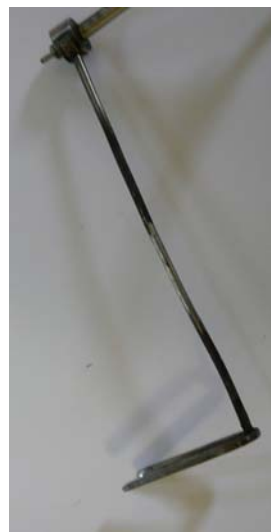
As can be seen from the photographs below, the pendulum crutch was broken and held together by an electrical junction box (left). The crutch was therefore repaired using silver solder (right).

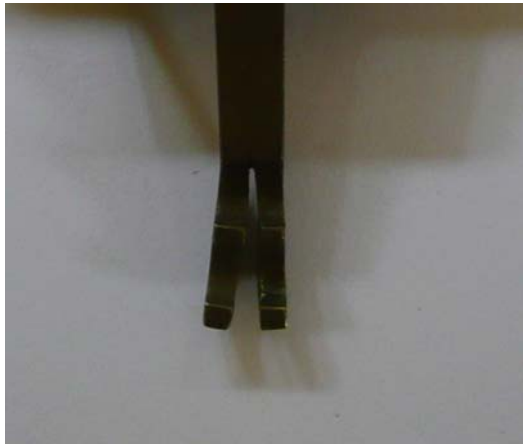
The pendulum suspension block had also been incorrectly adjusted by fitting a nail upon which to hang the pendulum suspension spring. The nail was removed and the suspension arm on the back cock repaired.

Damage to arm. 'Fingers' were closed to achieve correct position

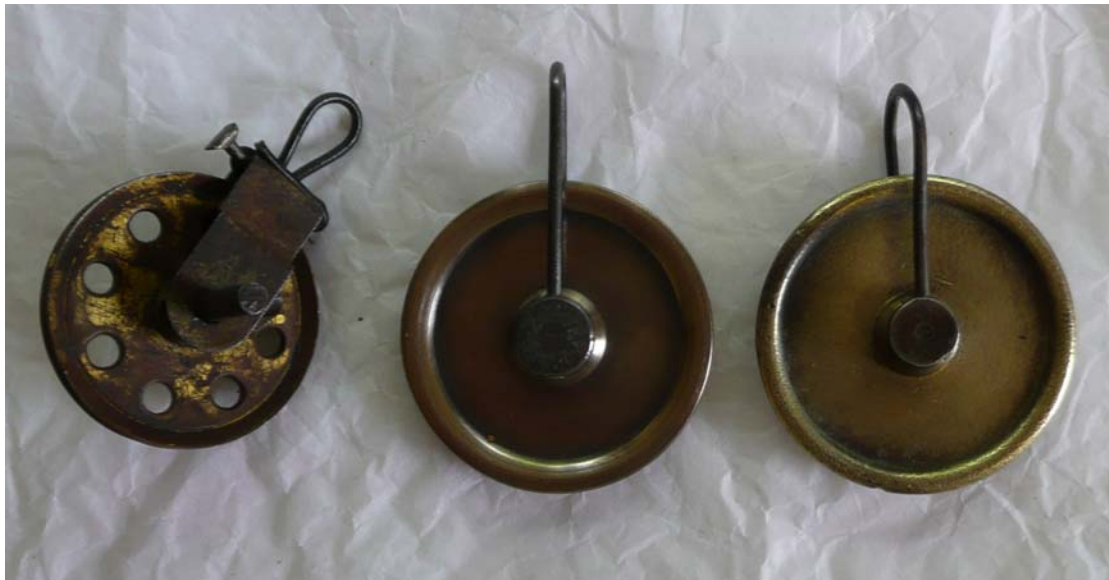
As previously mentioned, one of the driving weight pulleys was missing and a Meccano wheel had been used in its place. A new pulley was purchased from a specialist supplier to match more closely the original and 'aged'.

Mechano wheel, new pulley and remaining original
