CONDITION REPORT AND TREATMENT PROPOSAL

OBJECT: A mid 18th Century South German Fauteuil

OWNER: Edward James Foundation

TREATMENT REPORT

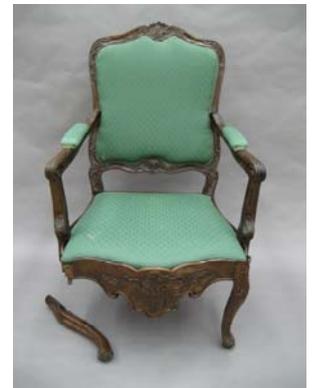
A mid 18th century South German walnut commode Fauteuil chair in rococo style. The chair has more recently been converted for use as a regular chair by the removal of the commode pan and the associated surrounding supporting frame.

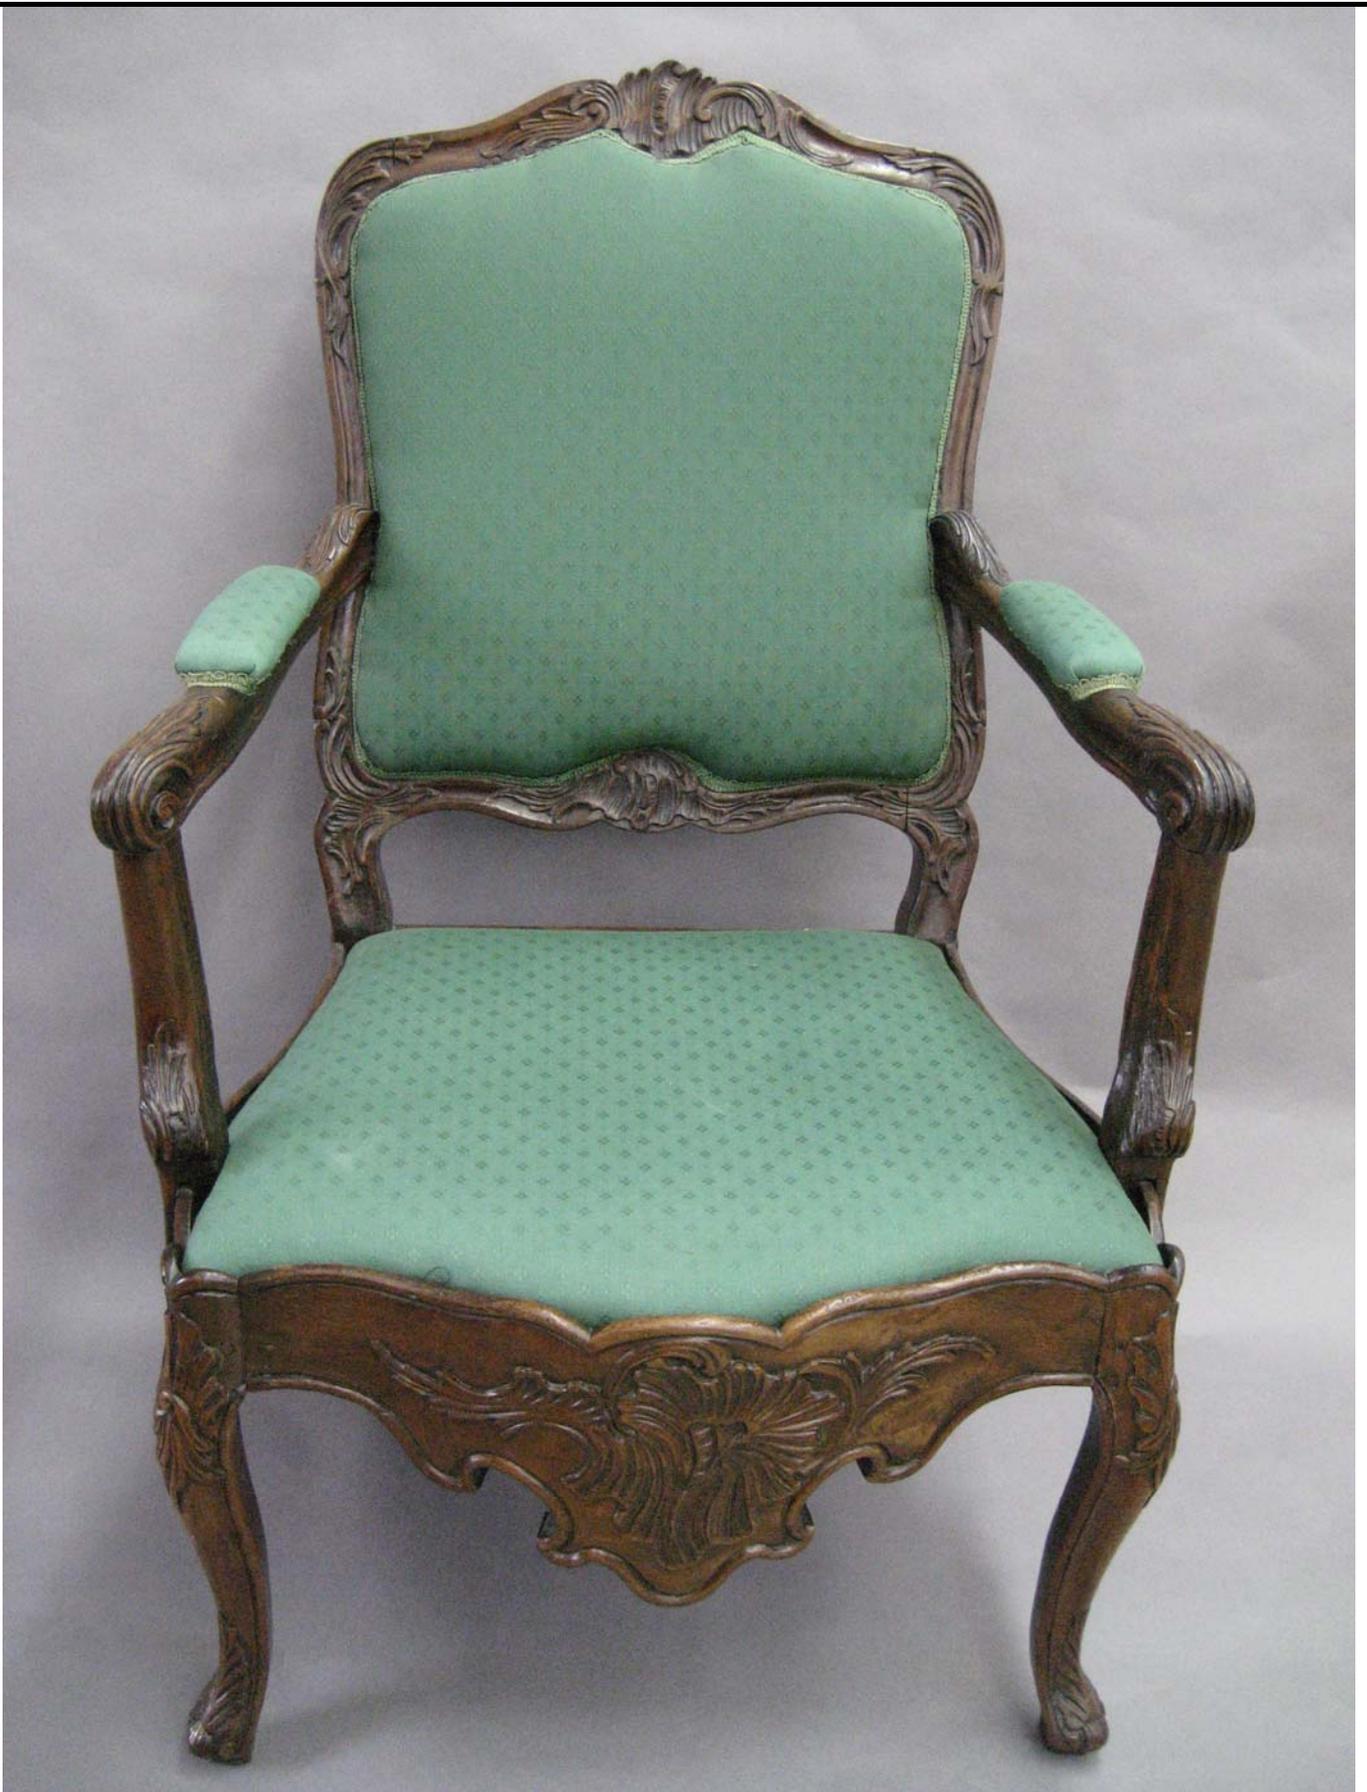
The front gate was then glued into place using hide glue and replacement walnut pegs where necessary. The pegs were trimmed flush and sealed with shellac. Gaps and remaining small losses were then filled with stopping wax before the surface of the whole chair was waxed using proprietary beeswax.
