Hampshire Antique Restoration

CONDITION REPORT AND TREATMENT PROPOSAL

OBJECT: Mid 17th Century Italian Walnut Armchair

TREATMENT REPORT

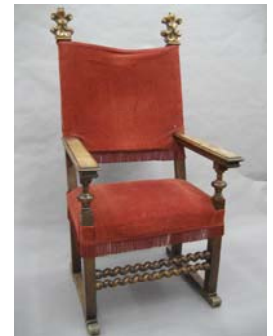
The red velvet upholstery is a relatively recent replacement and is edged with a modern red fringing. The chair has had some significant structural repairs in the past.

The PR rear stile has had a scarfed splice let in where the PR seat rail joins the stile, and a section of the PR arm around 11cm long has been spliced in to the PR arm where it meets the stile. The PR turned arm support

has had a previous – probably dowelled – repair, which is loose and unstable.

There is evidence of extensive common furniture beetle damage to the item, especially the front legs and both feet rails, which are extensively weakened eroded and pitted with flight holes. All of this previous infestation appears to be dormant. Stopping wax has been used to previously fill the flight holes – a large amount of which is now missing.

The gilded finials at the top of both rear stiles show evidence of extensive alteration. At some point they were removed from the chair with a saw – probably after some damage had occurred to them. They were then reconstructed with approximately 20% of the original retained and new walnut applied around it. At the same time a small ogee moulding was added as a lower collar to the finial – probably to allow the re-upholstery to continue up to the top of the rear stiles. The new timber was then carved, gessoed, boled, gilded and toned to the finish we see now. Finally the finials were re-attached to the chair with loose dovetailed tenons let into the rear of the stiles, more recently secured with screws.

After careful dismantling the original joints will be cleaned of degraded old glue. The sections of frame weakened by common furniture beetle damage will be consolidated for strength and appearance and the whole chair re-assembled with walnut veneer packing used to eliminate the play in the mortice and tenon joints. The replacement upholstery will be applied with a conservation upholstery approach minimising further damage to the frame.
