CONDITION REPORT AND TREATMENT PROPOSAL

OBJECT: Early 19th Century Pietre Dure Marble Specimen table

OBJECT NUMBER: 2345-08-F

OWNER: Edward James Foundation

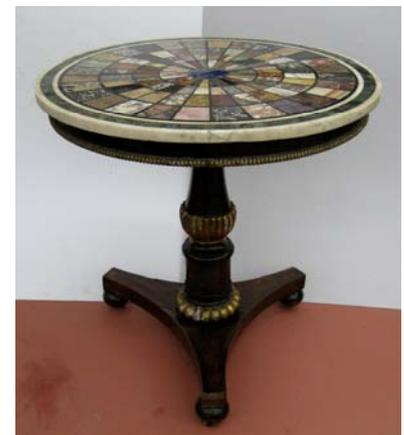
An early 19th century Pietre Dure marble specimen table supported on a simulated rosewood and parcel gilt columnar base above a trefoil platform base raised on bun feet and brass castors (Picture 1)
