CONDITION REPORT AND TREATMENT PROPOSAL

OBJECT: Early 19th century Gilded Convex Mirror

OBJECT NUMBER: 2322 - 08 - F

TREATMENT REPORT

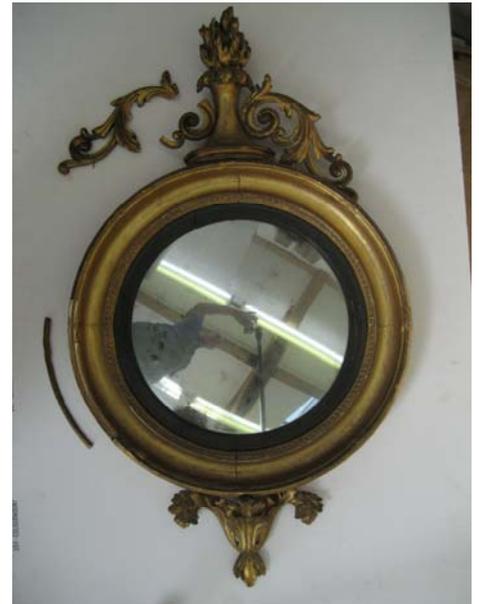
An early 19th century Regency Convex mirror.

The main frame and attached decorative components are constructed from pine. The main mirror frame has 4 joints around the circumference and both the top and bottom carved elements are attached to a section of timber screwed into the rear of the main frame.

The convex mirror is surrounded by a reeded ebony slip frame and is held in place by a pine planked back fixed into place with clout nails and covered with a paper backing.
