## CONDITION REPORT AND TREATMENT PROPOSAL

**OBJECT:** Early 19<sup>th</sup> century Mahogany work table

**OBJECT NUMBER:** 2278 - 06 - F

## TREATMENT REPORT

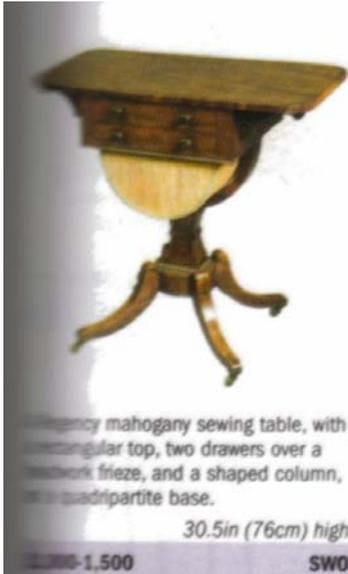
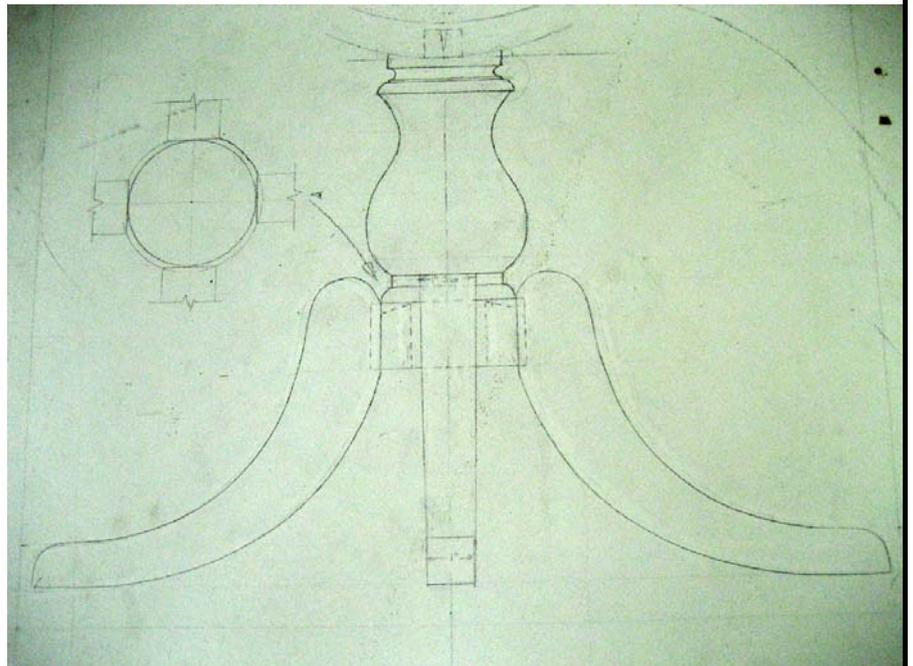
The evidence gathered all concludes that this small regency work table started out life with a semi-circular support, probably on sabre legs. The materials, tool marks and constructional techniques used seem to suggest the alterations took place most likely in the first half of the 20<sup>th</sup> century.

After research and client approval a base in keeping with the original style will be made to replace the married on legs as shown in the original picture.

After research (left) it was decided to work up a proposal (below) based on an “average” of likely originals.
